Fresh From
Historic
Bucks County Farms

A Companion to
Fresh From Bucks County Farms: A Guide to
Roadside Markets & “Pick Your Own” Farms

2011

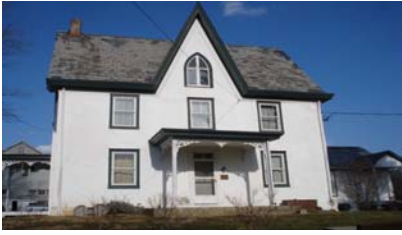
Farm # 19

The driveway leading to the Fairview Farm Market will afford you a great view the farmhouse. This home is a collection of several additions. The original is most likely to the right due to the visible corner quoins. Notice evidence in the stone work of the existence of a door where the center-most first-floor window is now. Each subsequent addition was added to the left of this first section. This home was most likely covered in plaster during some of its lifetime as small fragments still remain.

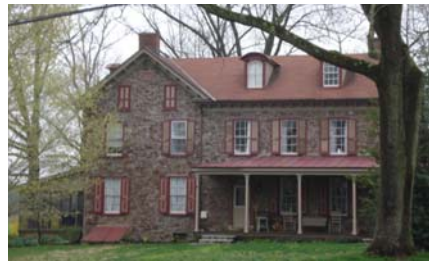
Farm # 34

At the Milk House Farm Market customers will be able to see two stone farmhouses and the barn. The home (pictured here) located across the road from the market bears a date stone of 1856 in the frontward facing gable.

Notice that the shutters on the second floor are louvered, but the first-floor shutters are not. This feature afforded additional security overnight on the first floor while allowing for air flow on the second. Additional interest is achieved by the segmental arch dormer windows and eve brackets.

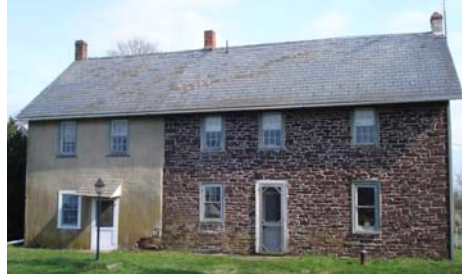
Penn Vermont Fruit Farm* Farm # 45
Rt. 113 & Rolling Hills Rd
Bedminster PA 18910

Here visitors will be able to see the home built by Abraham and Magdalena Fretz in 1820. The stone section to the right in the photo is the earliest portion. The stucco section to the left in the photo was originally only a one-story structure that served as a summer kitchen. In 1925 the second floor of this section was added. The Fretz Family purchased the farm in 1737, and their descendents remained there until 1982 when the current owner purchased it. In addition to the home, visitors will see a barn that most likely predates the house and 20th century press house, which is still used to make apple cider to this day. (Source: Kenneth Bupp) This farm was preserved by the Bucks County Agriculture Preservation Program in 1991.

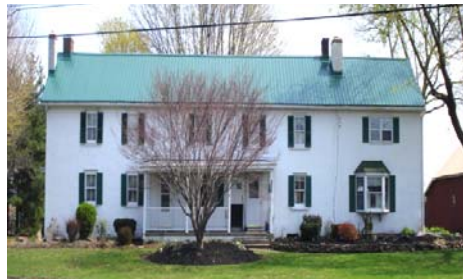
Penn View Farm* Farm # 46
1433 Broad St
Perkasie PA 18944

Penn View Farm offers visitors to the market a scenic view of the farm and its buildings. Elmer Umstead named the farm after he became owner in 1903 because by using field glasses he claimed to be able to see William Penn's statue in Philadelphia on a clear day. While this is no longer possible, the two-story stucco Bucks County farmhouse is highly visible from the market. The oldest section of the home is the portion left of center in the photo, which was built in 1852 by David R. Rickert. It is presumed that sometime between 1848 and 1880 Samuel W. Myers built additions to both sides of this center portion. The most recent addition (far right in photo) was put on by the current homeowners in the 1970s. (Research by Della A. Ulmstead Shelly, June 1950).

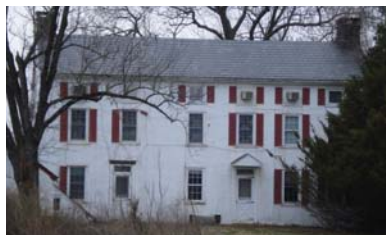
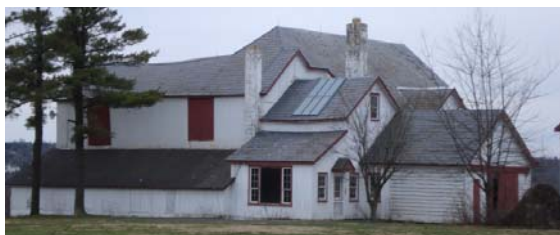
Farm # 73

From the Wrightstown Farmers' Market you will see Chippewa Farm with its three-story farmhouse, smokehouse, and barn. The Albert Thompson house bears a date stone which reads AST 1849. The multi-section barn is an assemblage of several structures, which creates an interesting view for market shoppers.
